Pest Report

5 Sample Avenue
SAMPLETON

Visual Timber Pest Report

Inspection Date: 20 January 2014
Report Prepared Date: 20 January 2014

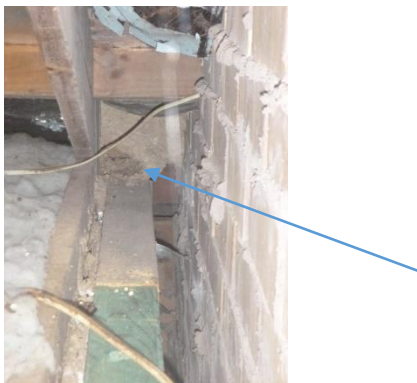
- Wine barrel at the pool
- SW corner of the roof cavity

Termite nest at the SW corner of the roof cavity

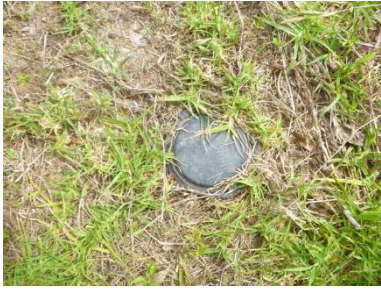
- Reticulation system installed at the rear paving
- Termite monitoring and baiting stations sighted around the house

Termite baiting and monitoring stations installed

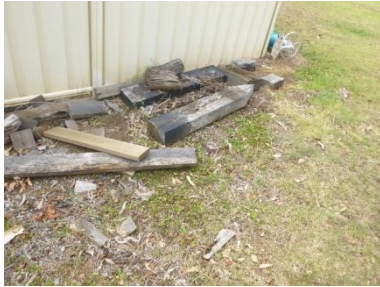
Remove loose timbers from around the property

- Influence of nearby areas (paddock on the southern side of the garage) where there is dense foliage that may encourage timber pests
- Hardwood landscaping timbers in contact with the ground - remove or replace with treated timber
- Trees and stumps located around the grounds of the property have the potential to harbour termite nests - test drill and treat if applicable
- Remove loose timbers from around the property
