Building Report

5 Sample Avenue
SAMPLETON

Report Prepared: 9 January 2015

Residential Building Report

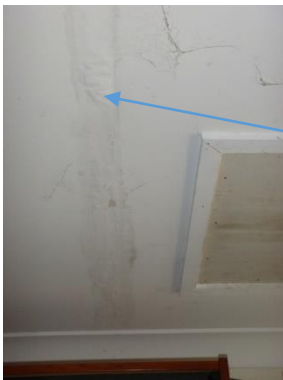
- Water staining and damage present to the garage ceiling. The damage is directly under the pipe penetrations of the HWS located on the roof. We recommend further investigation and rectification of the roof flashings by a licenced roof plumber
- Moderate corrosion damage present in the rear roller door of the garage. Replacement will be required in due course
- Stored items significantly restricted the inspection to the interior of the garage. Further inspection of the concealed areas is strongly recommended prior to the exchange of contracts, if possible, as they could possibly contain defects. No responsibility can be held by the consultant for any defects concealed at the time of the inspection.
- The garage floor was covered with carpet no inspection of the concrete slab was carried out

Water staining present to the ceiling lining south of the roof access

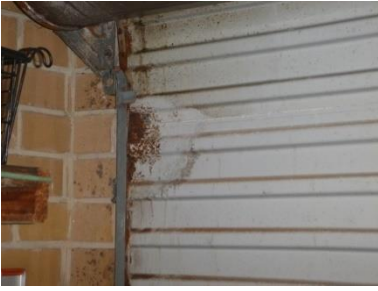
Moderate corrosion to the garage door

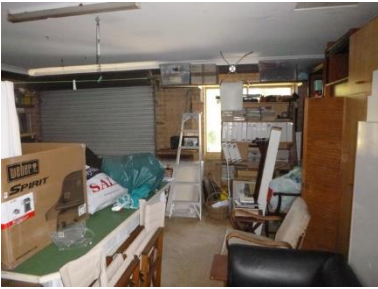
Stored goods significantly restricted the inspection of the garage

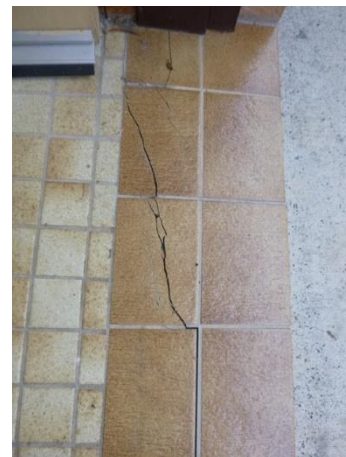
Cracked threshold tiles

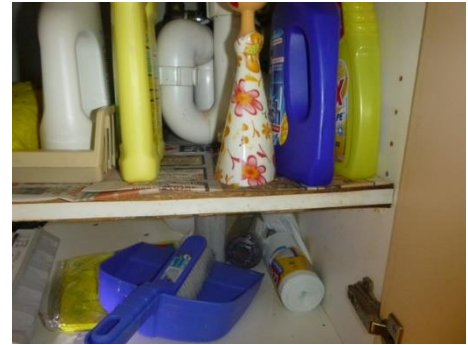
- Ceilings and Cornices - no significant defects
- Architraves and skirtings - no significant defects
- Fit out/Cabinets - water penetration, dampness
 - The cabinet and shelf of the kitchen sink cabinet has deteriorated due to moisture exposure - whilst no leakage was noted at the time of the inspection further investigation by a licenced plumber is strongly recommended

The cabinet and shelf of the kitchen sink cabinet has deteriorated due to moisture exposure

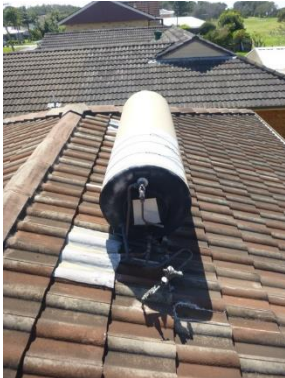
- Mains pressure roof mounted solar system
 - The base of the solar panel frame has moderate deterioration present – replacement may be required in the near future
 - The hot water system appears to be in working condition. No specific tests other than running the hot water from the tap were carried out. No determination has been made as to the suitability or adequacy of the hot water system in relation to capacity or otherwise.

All hot water services need to be inspected and reported on by a plumber and/or electrician. It is recommended that a licenced plumber and/or electrician be consulted for further advice.

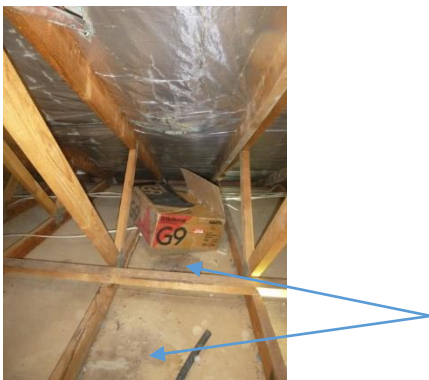
- The roof flashings around the HWS pipes appear to be leaking. Water staining and damage present to the top of the ceiling linings and buckets have been placed under pipe penetrations to catch any dripping water - recommend pipe penetrations and flashings be further inspected and repaired by a licenced roof plumber to prevent further damage to ceiling linings and roof trusses

Water staining present to the ceiling lining under the HWS pipe penetrations

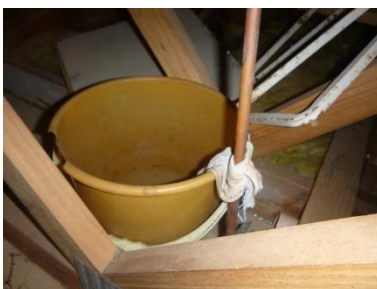
Buckets placed in the roof cavity to catch dripping water

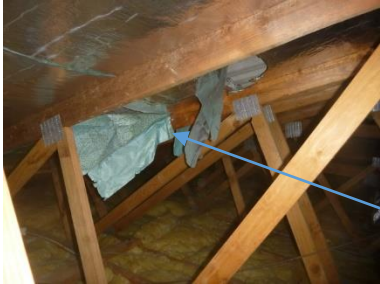
- Sarking has been installed in the roof cavity
 - The sarking has been damaged in some areas - holes and tears reduce the effectiveness of the sarking as a moisture and insulation barrier. To maximise benefit, where possible, the sarking should be repaired with bitumen tape

Damaged sarking present above the living room

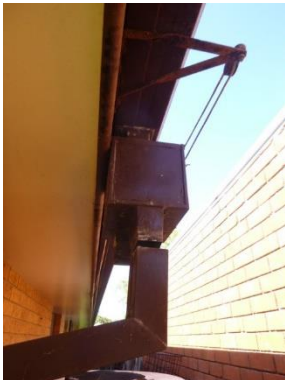
- The downpipe connection at the NW corner of the building has been connected to a pulley to switch between tank and downpipe, the connection is not operational - recommend a roof plumber be consulted to provide cost and scope of rectification. Excess moisture around the house encourages foundation movement and timber pest activity
- Apply silicone to downpipe and gutter joints as they appear to be leaking

We strongly recommend a licenced plumber inspect and detail the requirements to ensure that the gutters and downpipes are functional and adequate for the situation.

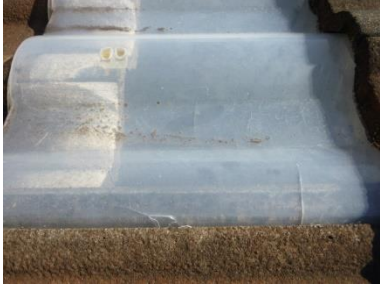
- The plastic skylight tiles have hairline cracks present - replacement is recommended to prevent possible water leakage into the house

The plastic skylight tiles have hairline cracks
