## Building Report

### 64 Sample Street Samletown

# Pre-Purchase Inspection

## Residential Building Report

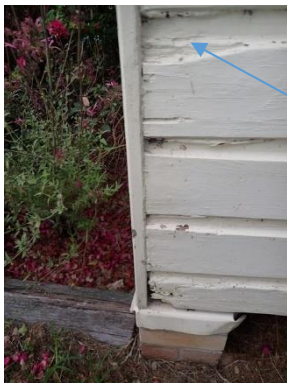
- Several of the weather boards at the western side of the kitchen and at the eastern side of the bathroom have moderately deteriorated, further more significant deterioration is likely to occur if repairs are not carried out - repairs and regular painting is recommended
- Impact damage present to the fibrous wall cladding of the laundry. These panels may contain asbestos and should only be repaired by a suitably qualified professional

Some of the weather boards at the western side of the kitchen have moderately deteriorated,

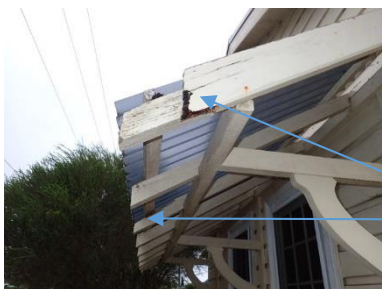
- Moderate deterioration present to the ends of rafters and barge board of the western living room awning

Moderate deterioration present to the ends of rafters and barge board of the western living room awning

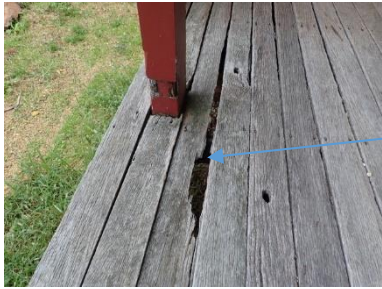
- Several decking boards of the front verandah have deteriorated and are therefore a safety hazard as persons could fall through the deck
- The exposed ends of several decking joists at the southern and eastern sides of the front verandah present moderate deterioration
- The hardwood bearers at the southern side of the front verandah have moderately to extensively deteriorated, they have been weakened and are therefore a safety hazard
- The base of the SW verandah post has moderately deteriorated
- We recommend a builder be engaged of cost and scope of rectification of the above defects

Deteriorated decking at the western side of the front verandah

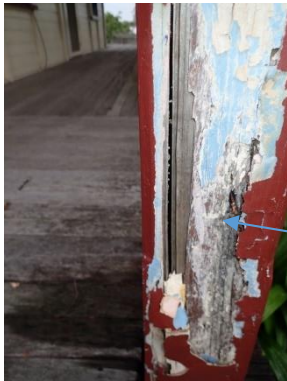
Moderate deterioration to the base of the SW verandah post

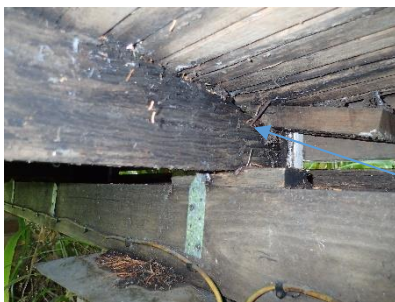
The end of a southern deck joist has deteriorated

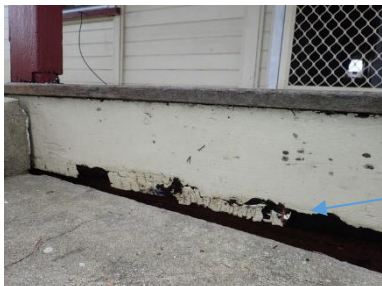
The timber fascia at the southern side of the verandah has deteriorated

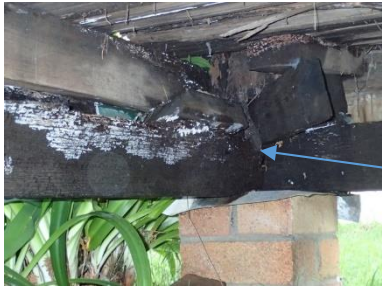
Deck joists, bearer and base of verandah post at the SW corner of the verandah have moderately to extensively deteriorated

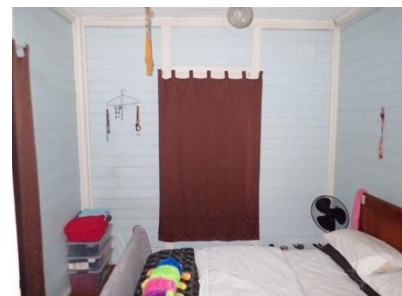
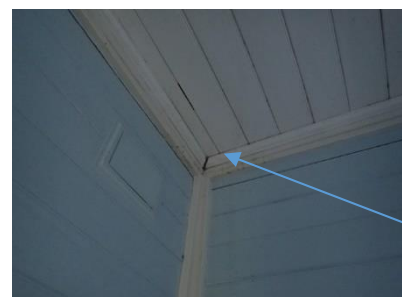
- Ceilings and Cornices - water penetration, dampness
  - Drip marks present to the ceiling at the NW corner of the room is indicative of leakage from the deteriorated valley gutter above - refer to roof exterior section
- Architraves and skirtings - no significant defects
- Walls Interior - no significant defects
- Windows Internal - no significant defects
- Doors - no significant defects

Drip marks present to the ceiling at the NW corner of the room

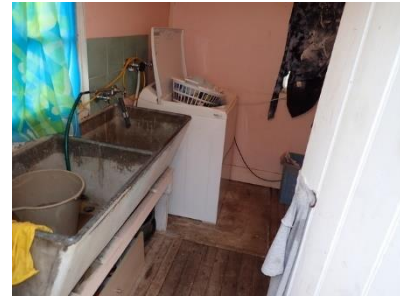
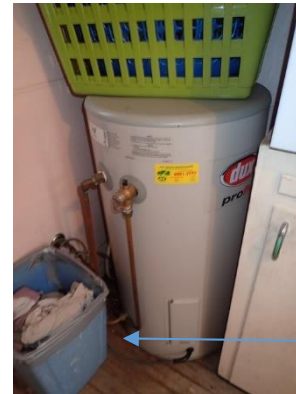
The timber flooring at the eastern side of the room is spongy

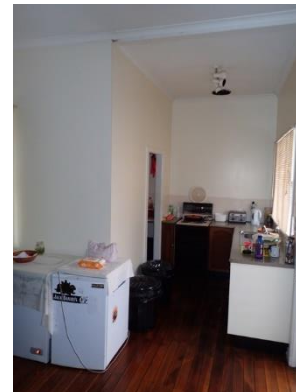
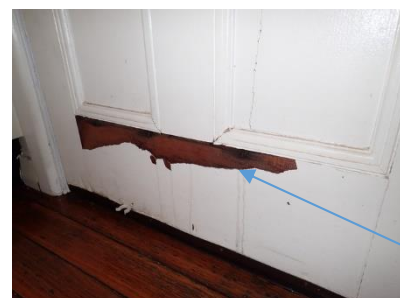
The eastern entrance door is damaged at the base

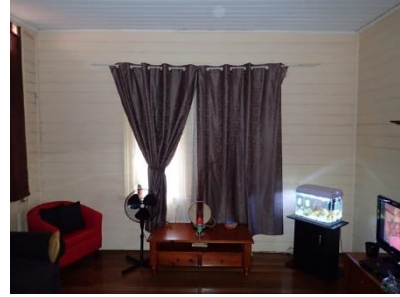
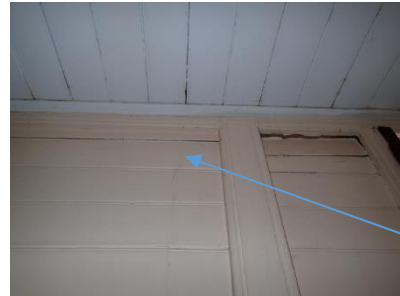
Drip marks present to the southern wall lining indicative of leakage from the valley gutter above

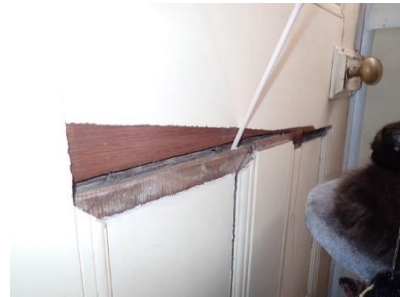
The northern external door is damaged at the base

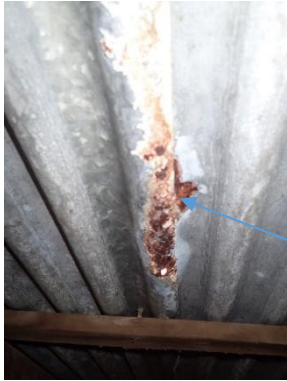
- Several corrosion holes noted to the underside of the metal deck roof covering - the metal deck roof covering requires replacement to prevent possible water penetration into the house

Corrosion holes present in the joins of the metal deck roofing

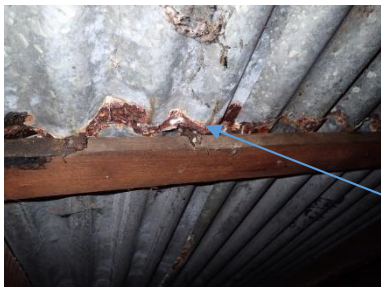
Corrosion holes present in the joins of the metal deck roofing

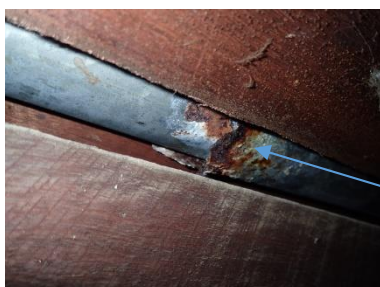
Corrosion holes are developing in the joins of the valley gutters

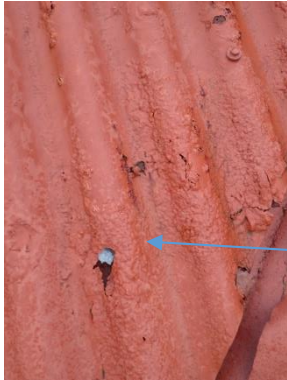
- The metal deck roof covering presents extensive corrosion damage and corrosion holes, water penetration into the house may occur - we strongly recommend a roof plumber be engaged for cost and scope of replacing deteriorated roofing prior to purchase

The metal deck roof covering presents extensive corrosion damage and holes

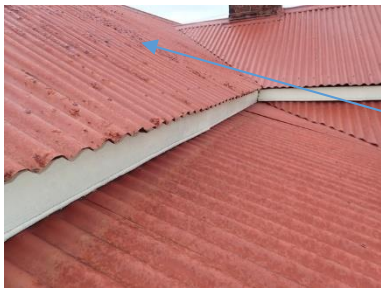
The metal deck roof covering presents extensive corrosion damage

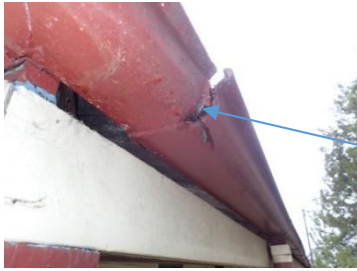
The gutter at the SW corner of the front verandah has rusted and could leak. Some of the gutter joints where leaking where they have spread

*We strongly recommend a licensed plumber inspect and detail the requirements to ensure that the gutters and downpipes are functional and adequate for the situation.*

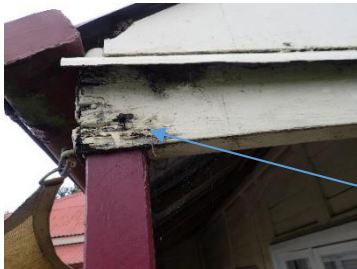
The gutter was overflowing at the northern side of the rear verandah. The verandah beam has started to deteriorate as a result of being constantly moist

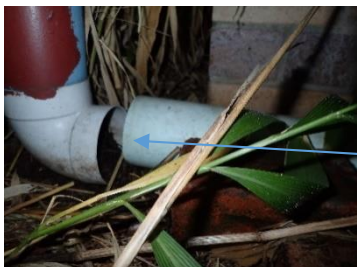
A southern downpipe is discharging into the subfloor where it has come apart at the joint

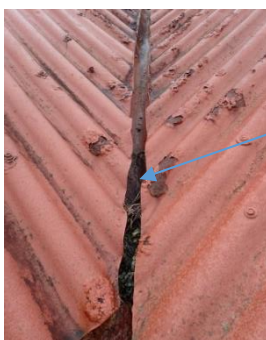
- Corrosion damage present to some valley gutters, leakage into the house was noted at the SW corner of bedroom 3 - replacement of the deteriorated valley gutters is recommended

Corrosion damage present to some valley gutters

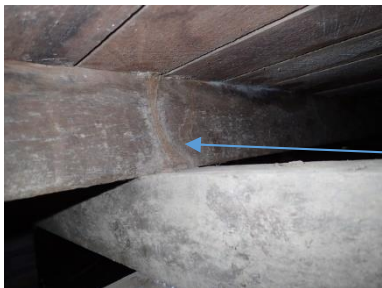
Termite workings to a floor joist under bedroom 1

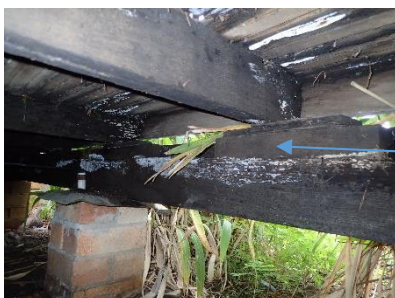
- Packing noted between bearer and piers and deck joists at the front verandah is indicative of pier subsidence over time. The southern down pipes are discharging into the subfloor in this area. Moisture in the subfloor is conducive to foundation movement

Packing noted between bearer and deck joists at the front verandah is indicative of pier subsidence over time

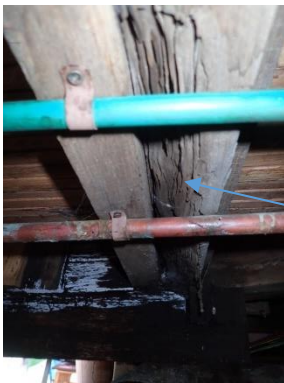
Moderate damage caused by termites present to a deck joist at the southern end of the rear verandah

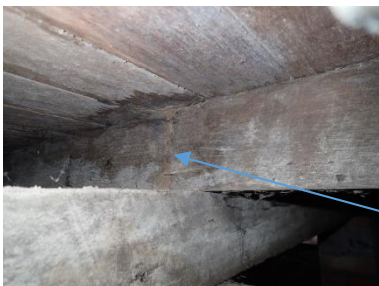
Termite workings noted to a floor joist under bedroom 2

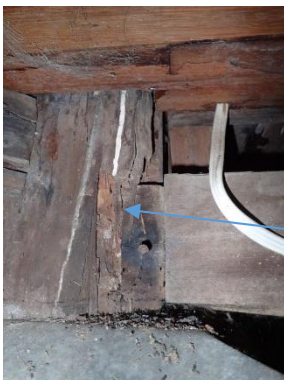
Slight damage caused by termites present to a wall stud at the southern side of the bathroom

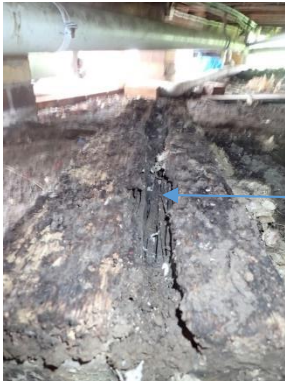
Termite damage to loose timber under the hallway

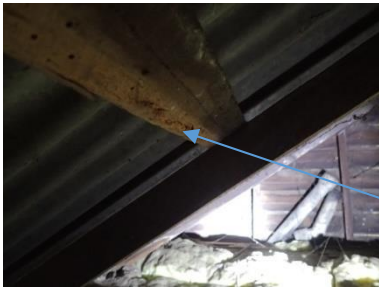
Moderate damage caused by borers present to a roof batten at the western side of the kitchen

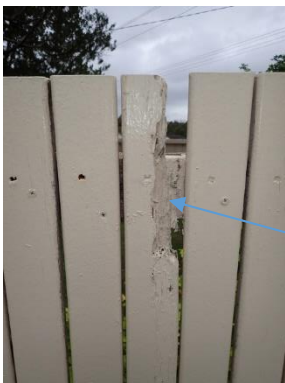
Timber fence palings have deteriorated

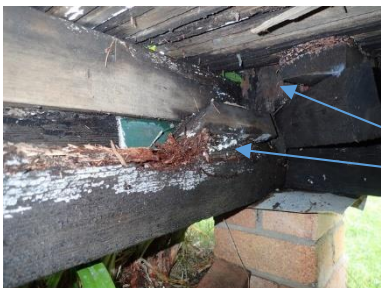
Extensive deterioration noted to the bearer, deck joists and base of verandah post at the SW corner of the front verandah

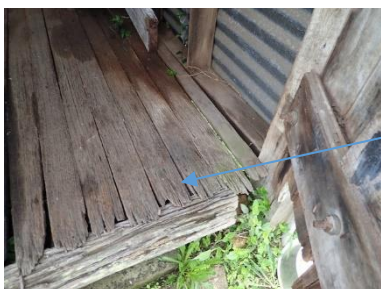
The garage floor is springy and has deteriorated

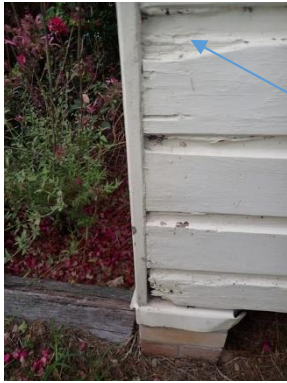
Some of the weather boards at the western side of the kitchen have moderately deteriorated,

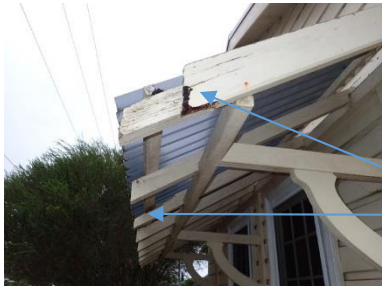
Moderate deterioration present to the ends of rafters and barge board of the western living room awning

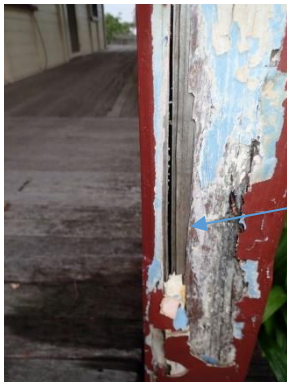
Moderate deterioration to the base of the SW verandah post

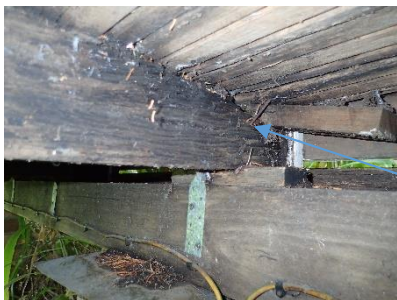
The end of a deck joist has deteriorated at the southern side of the front verandah

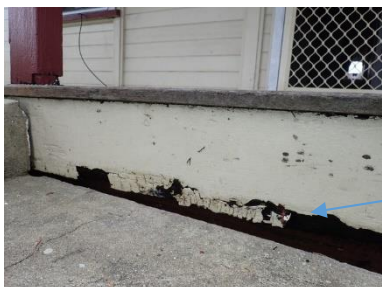
The timber fascia at the southern side of the verandah has deteriorated

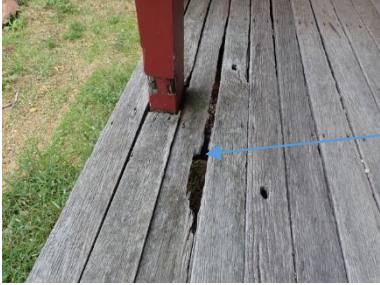
- Yes
- Extensive deterioration caused by wood decay fungi at the front verandah is a safety hazard as persons could fall through the deck

Deteriorated decking at the western side of the front verandah is a safety hazard
