Pest Report

64 Sample Street
Samletown

Visual Timber Pest Report

In accordance with Australian Standard 4349.3

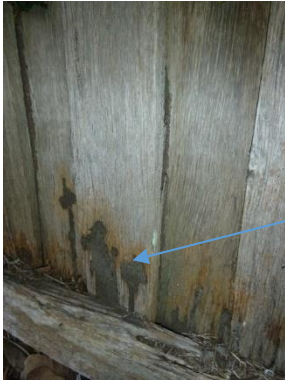
- Yes, *Nasutitermes* Spp, the termites have the ability to cause moderate to extensive damage to structural timbers

Active termites were present in the timber fences at the NW side of the property

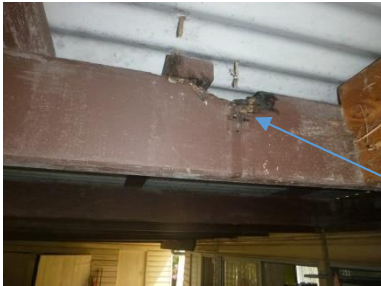
Moderate wood decay damage present to a pergola rafter at the western side of the kitchen

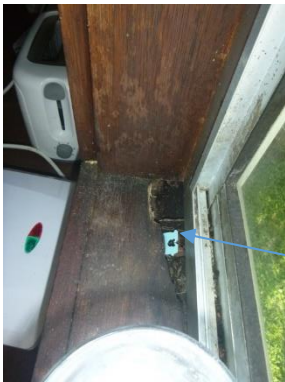
Wood decay damage to the kitchen window reveals

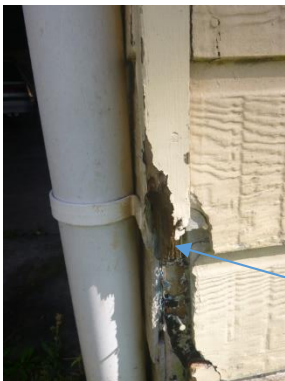
Moderate wood decay damage to the corner cladding battens – southern corner of the kitchen pictured

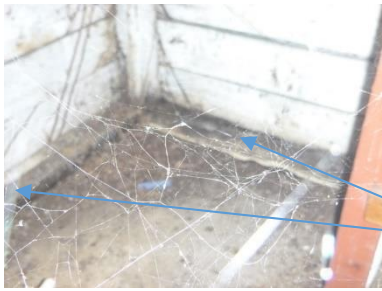
Extensive wood decay damage present to bottom wall plates at the southern and western sides of the garage

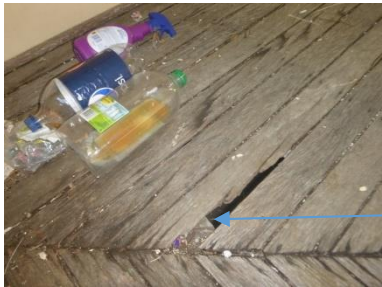
Moderate wood decay damage to the verandah decking

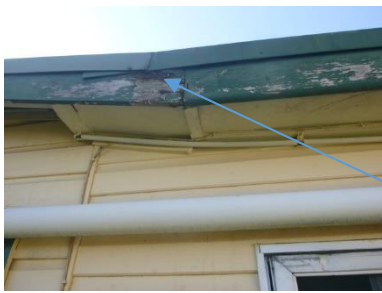
Moderate wood decay damage to the barge boards at the western corner of the house

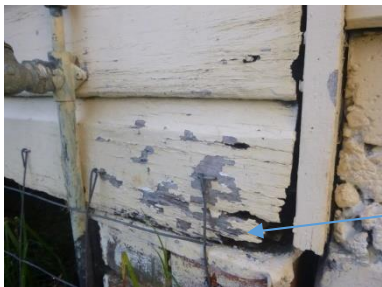
Moderate wood decay damage present to the ends of the cladding at the western corner of the bathroom

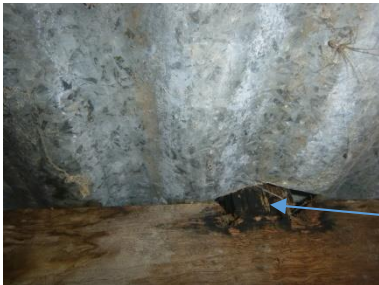
Moisture present at the base of the shower recess indicative of current leakage

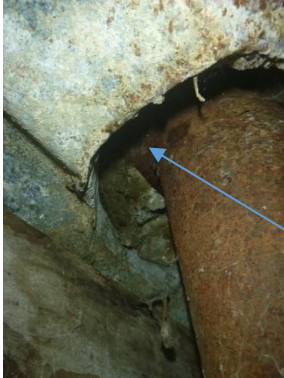
Moisture present at the base of the toilet pan indicative of current leakage

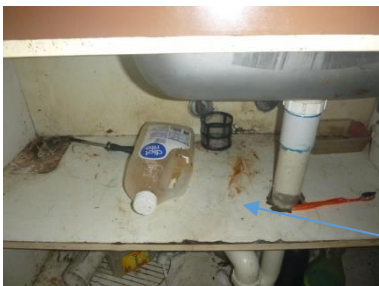
Moisture present in the kitchen sink cabinet indicative of current leakage

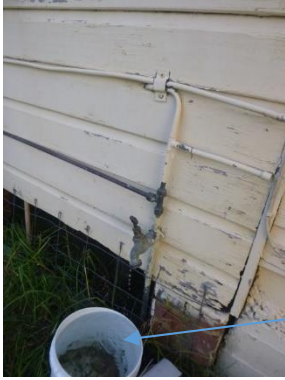
The NW exterior tap was dripping at the time of the inspection

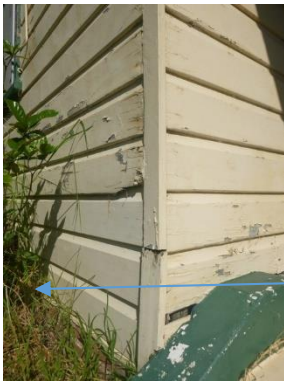
- Some of the wall cladding sits too close to ground level or is in contact with the soil, leaving these areas vulnerable to premature decay and termite attack. Cladding should ideally have 75 millimetres of ground clearance to help prevent decay and potential concealed termite entry. Consideration should be given to options such as upgrading termite barrier protection, removing soil and trimming of the boards etc.

Soil resting against the weather boards at the SE side of the house
