## Building Report

### 64 Sample Street Samletown

# Pre-Purchase Inspection

## Residential Building Report

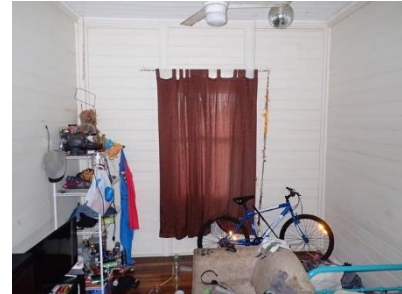
Overall condition: good

- Ceilings and Cornices - no significant defects
- Architraves and skirtings - no significant defects
- Walls Interior - no significant defects
- Windows Internal - no significant defects
- Doors - no significant defects

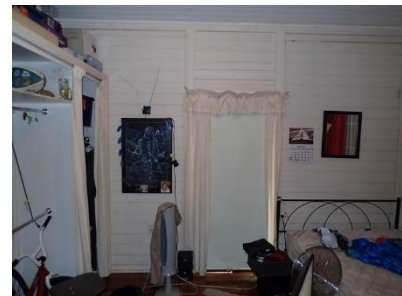
### Bedroom 2

Overall condition: good

- Ceilings and Cornices - no significant defects
- Architraves and skirtings - no significant defects
- Walls Interior - no significant defects
- Windows Internal - no significant defects
- Doors - no significant defects

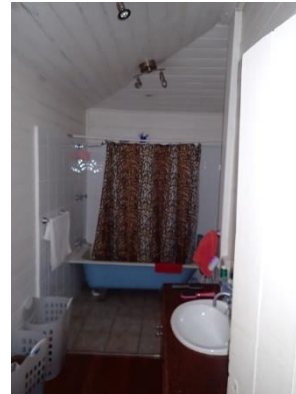
- Floor Tiles - installation
  - Several of the floor tiles are loose, this is indicative of adhesive or substrate issues - consult a licensed floor tiler for cost and scope of rectification

- Wall Tiles - no significant defects
- Doors - no significant defects
